Field visit Report on Landslide Site
(Village-Jakhan, Panchayat-Madrasoo, Tehsil Vikasnagar)
Dated: 17 August 2023

To study the possible causes/reasons of the current landslide/slope failure at Linghaf Road which impacted the Village-Jakhan. In compliance of orders received from Director General, ULMCC, a team of following officials visited the site on August 17, 2023 -

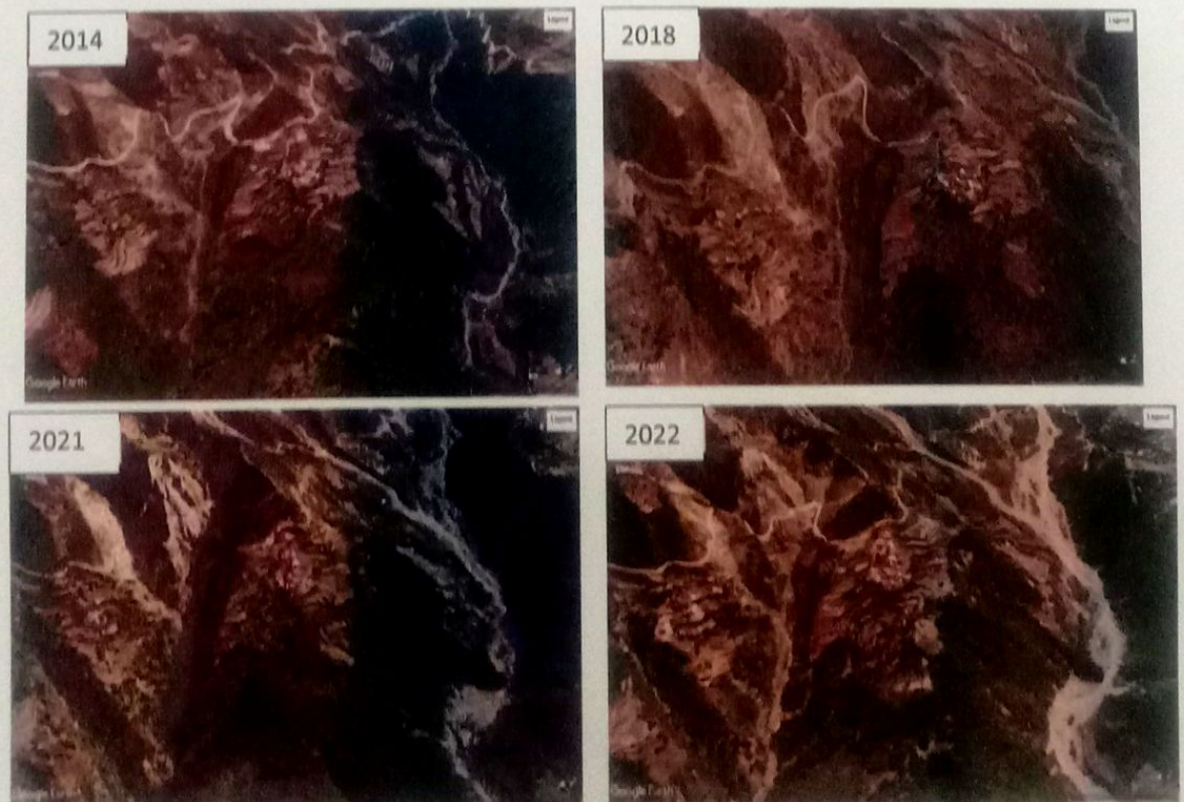
As per the following chronology of the spot a gradual widening of the rivulet can be clearly located. In the year 2011, there was a minor landslide event occurred along the rivulet.

Chronology of the spot deformation

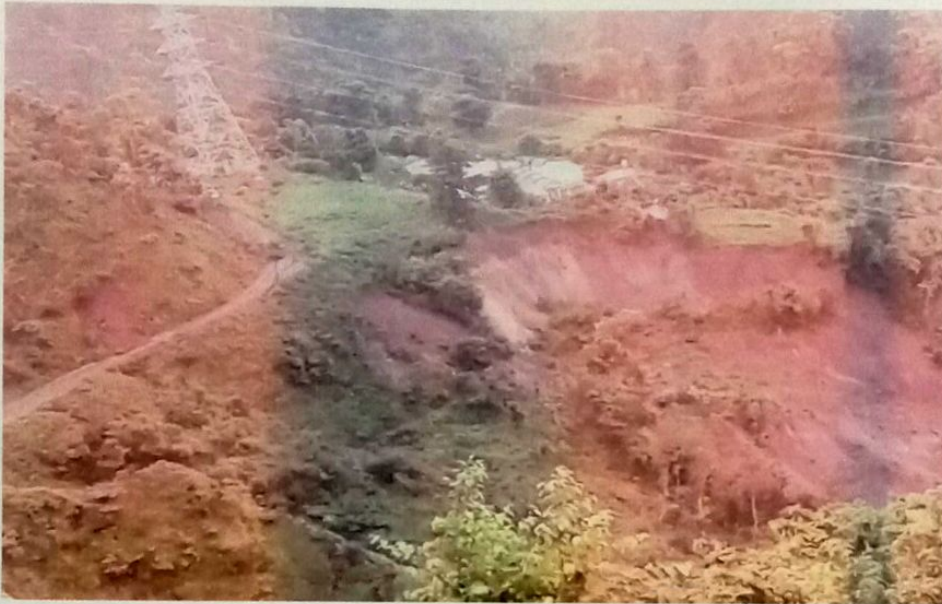
- i. As first event of landslide, a heavy rainfall occurred on August 13, 2023 (as informed by the dwellers) which slightly impacted the edge of rivulet, approx. 100 m. away (up-hill). No other impact or signs observed in the area.

Post Devastation landscape

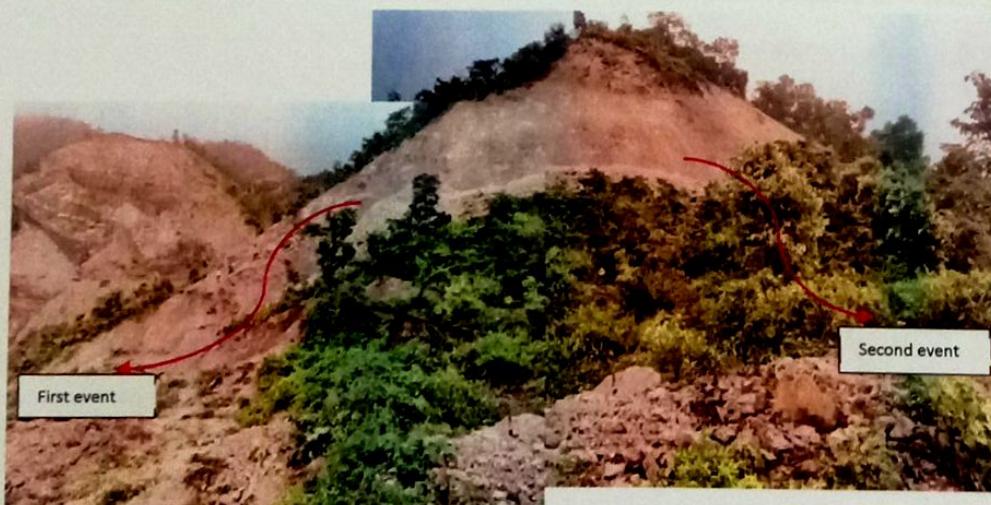
- ii. The second event of devastation occurred on August 16, 2023 in the post meridian. There were no rain showers observed on 14th to 16th August 2023.

Landslide scarp after first & second event

- iii. A landslide scar is 200 m wide and 70 m high (approximately) along the road side (towards up-hill) while towards valley side it is around 300 m. deep as slide/failure. A 200 m stretch of road washed out completely.
- iv. Foundation of one transmission line tower (Vyasi Hydro Power) is also damaged and due to traction one carrier of transmission line also found broken.
- v. Geologically, the soil forming slope is weak in nature and have least cohesion (binding parameter in soil). After observing the slope material in the vertical wide cracks, it is

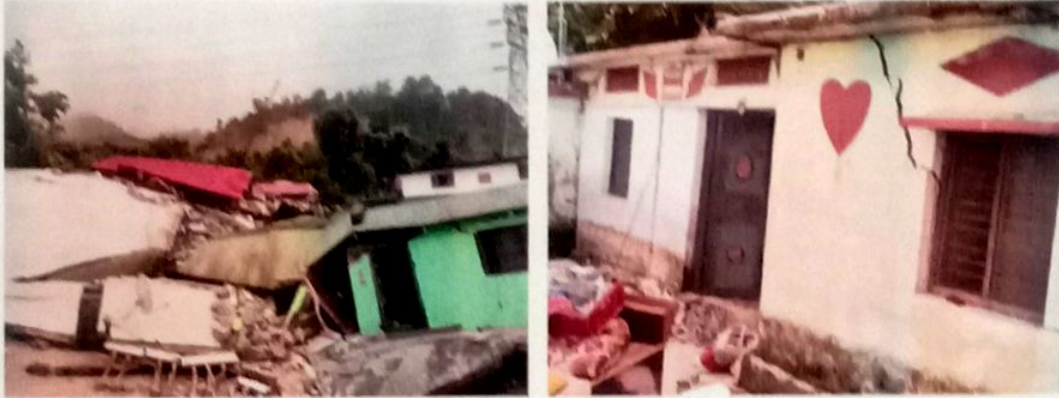
- vi. Fortunately, at the time of devastation all the dwellers were out of their houses and no life loss occurred. As per information received, out of 19 Households, 10 are considered totally damaged while 02 are partially damaged. Further, approx. 2 ha of arable land also covered by slide material.

Damaged House-holds

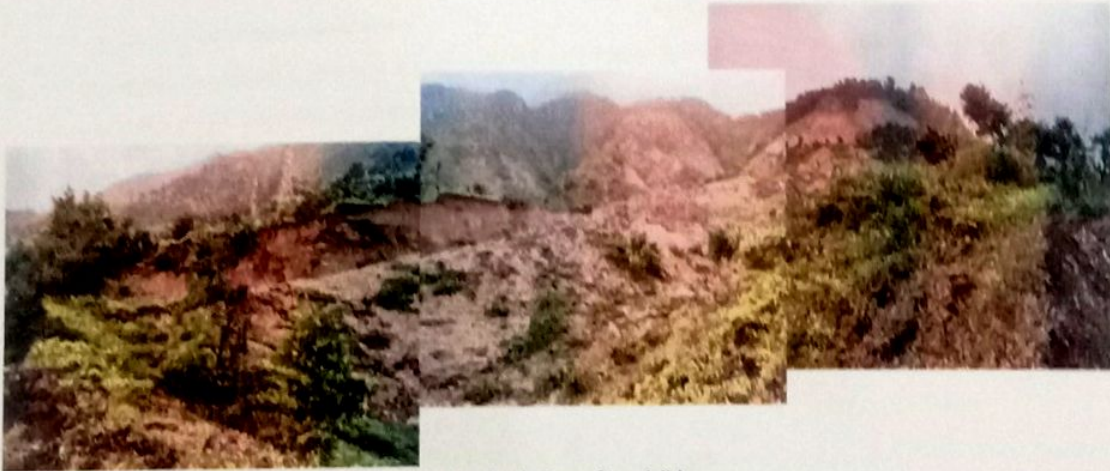
Longitudinal View of Landslide

- i. Approximate dimension of the scar is 200 m along the road side and 70 m high while towards valley side it may be approximately 300 m. The failure of surface has circular slip surface with average vertical depth lies about 40 m.
- ii. Slide material (scrap) consist of the soil, trees, other vegetations and road with breast wall which rest on the base as it is (with trees etc). The road & breast wall also slide and rested accordingly with major cracks on ground/slide surface. In the slide material, the cracks are found as significantly deep ranging from 40-120 cm (approx.) with varied width & length.

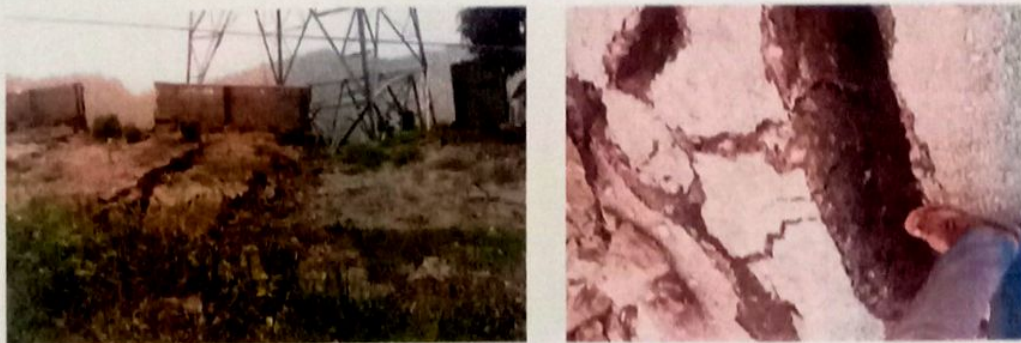
Longitudinal cracks on Ground

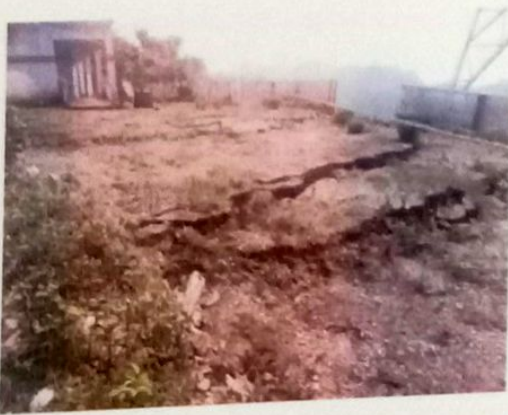
Crack on Ground of Government School

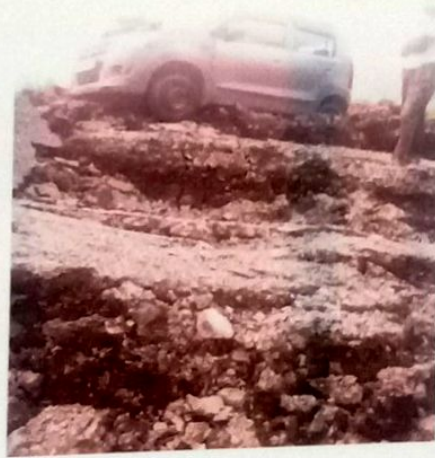
Ground Settlement along the longitudinal cracks

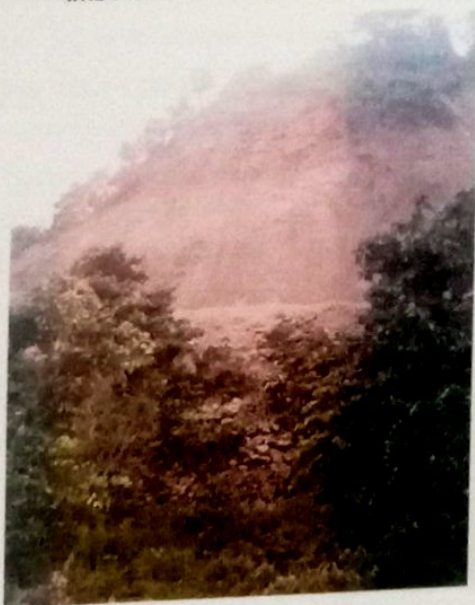
- iii. The slide material consists of variety of soil type, some of the material is found like wet clay with high organic carbon content. On other hand some material found as brittle and has no cohesion. Some angular chunks (less than 20 cm) of rock shale and slate imbedded in fine gain matrix is visible in the scar area.

Landslide scarp

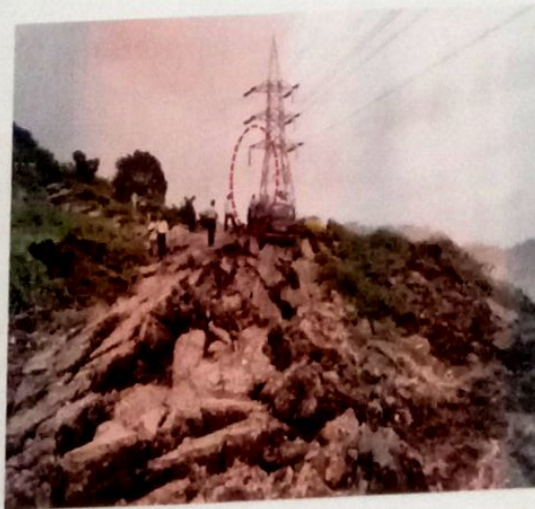
Damaged Transmission line Tower

- In near future, the possibility of slide/ failure of adjoining area of the scar cannot be ruled out, as the area seems to be unstable.
- The slide material is loose and susceptible to flow/sink further. As a precautionary measure, all the settlements must be remained evacuated till further orders.
- The land use of the concern land which is bearing slide material may be converted to other suitable purposes, eg- forest, and propose eco-restoration.
- Road construction to be done with geo-technical study and must be equipped with breast wall and retention wall or any other suitable work.
- The rivulet must be cure with suitable revetment works to check soil erosion/ widening.
- The electric supply must be repaired/ reconnect (including transmission line). Before repair/ reconnect the transmission line the foundation of tower(s) may be examined.
