**Preliminary Site Investigation of Landslides and Associated
Distress along the Hill Bypass Road around Mansa Devi,
Haridwar**

**Uttarakhand Landslide Mitigation and Management Centre
Government of Uttarakhand
August 2023**

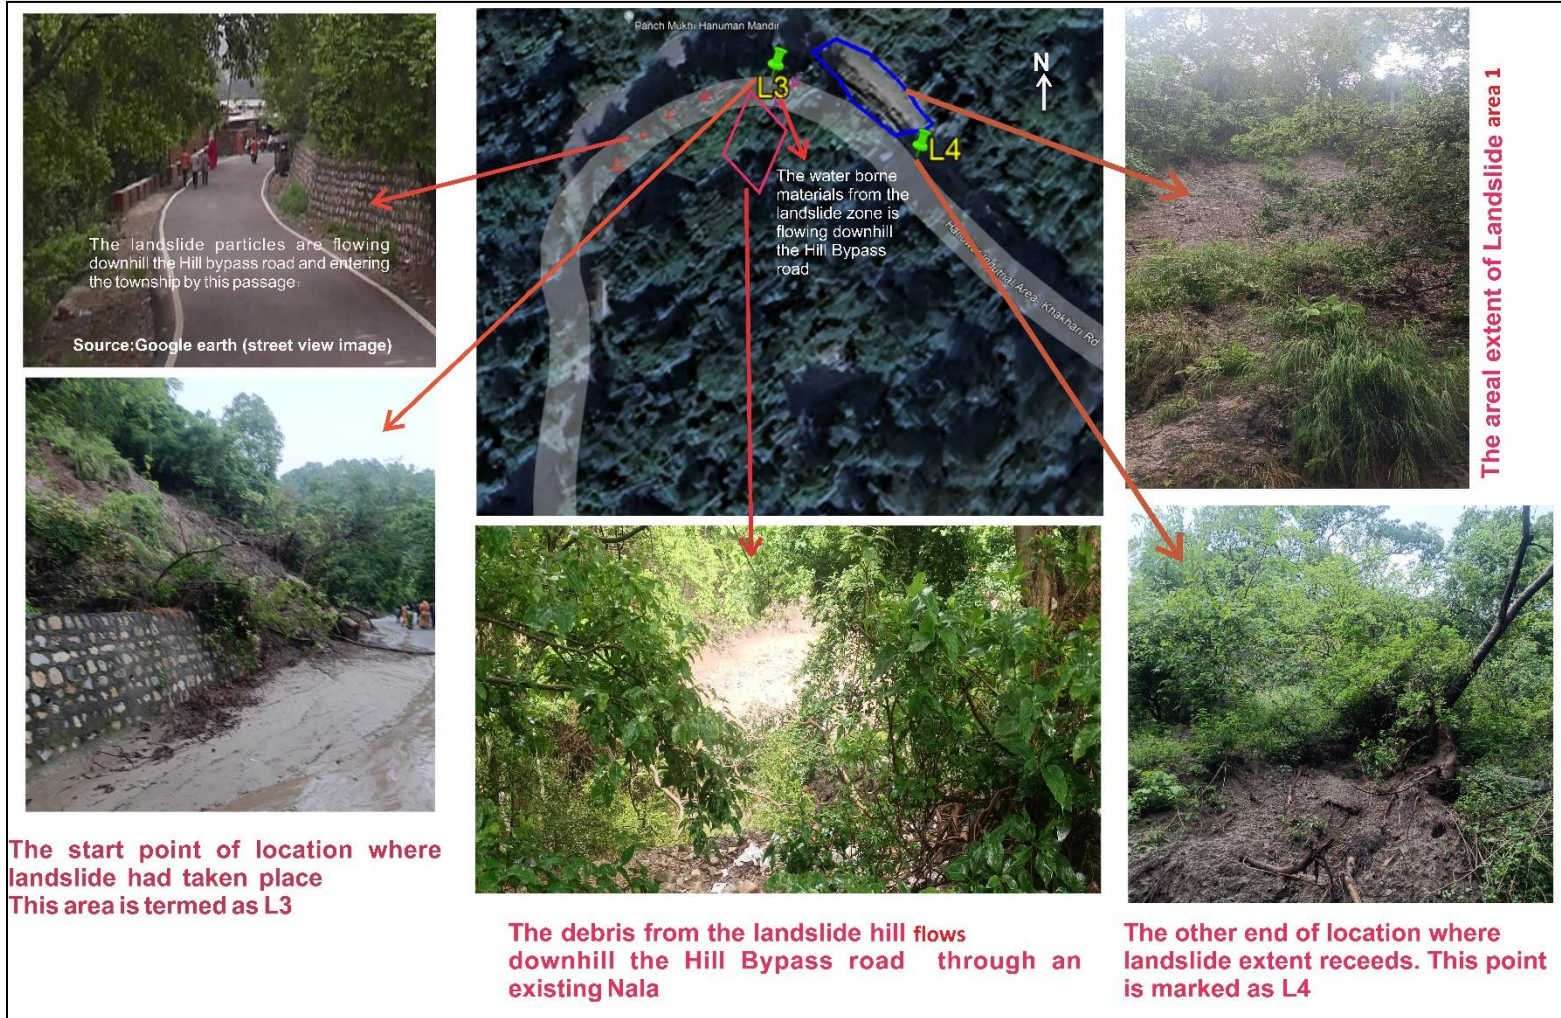
- i. **Landside Area 1:** This location is situated between the coordinates points L3 (29.955391° N, 78.163984° E) and L4 (29.955241° N, 78.164254° E) along the Hill Bypass Road, and is characterized by debris slide comprising mainly mud particles. The slope is estimated at $\sim > 80^{\circ}$ and of height ~ 30 m. This landslide has affected the road and caused disruption in the commute of the pilgrims. The

saturated materials borne by this landslide are entering the locations situated downhill which has flustered the daily routine of Haridwar township locals. Due to such invasion, problems like water logging, cracks and subsidence have aroused at certain locations (Fig. 4).

Fig. 4: Google Earth image showing the location of the first landslide, situated along the Hill Bypass road, points L3 and L4 mark the start and end point of the landslide stretch. It is also observed that landslide materials accompanied by water are flowing downhill in S (continuing straight by the road into an existing Nala) and SW (down the road into the township) direction. Each point marked in the Google Earth image is explained with respect to field photographs.

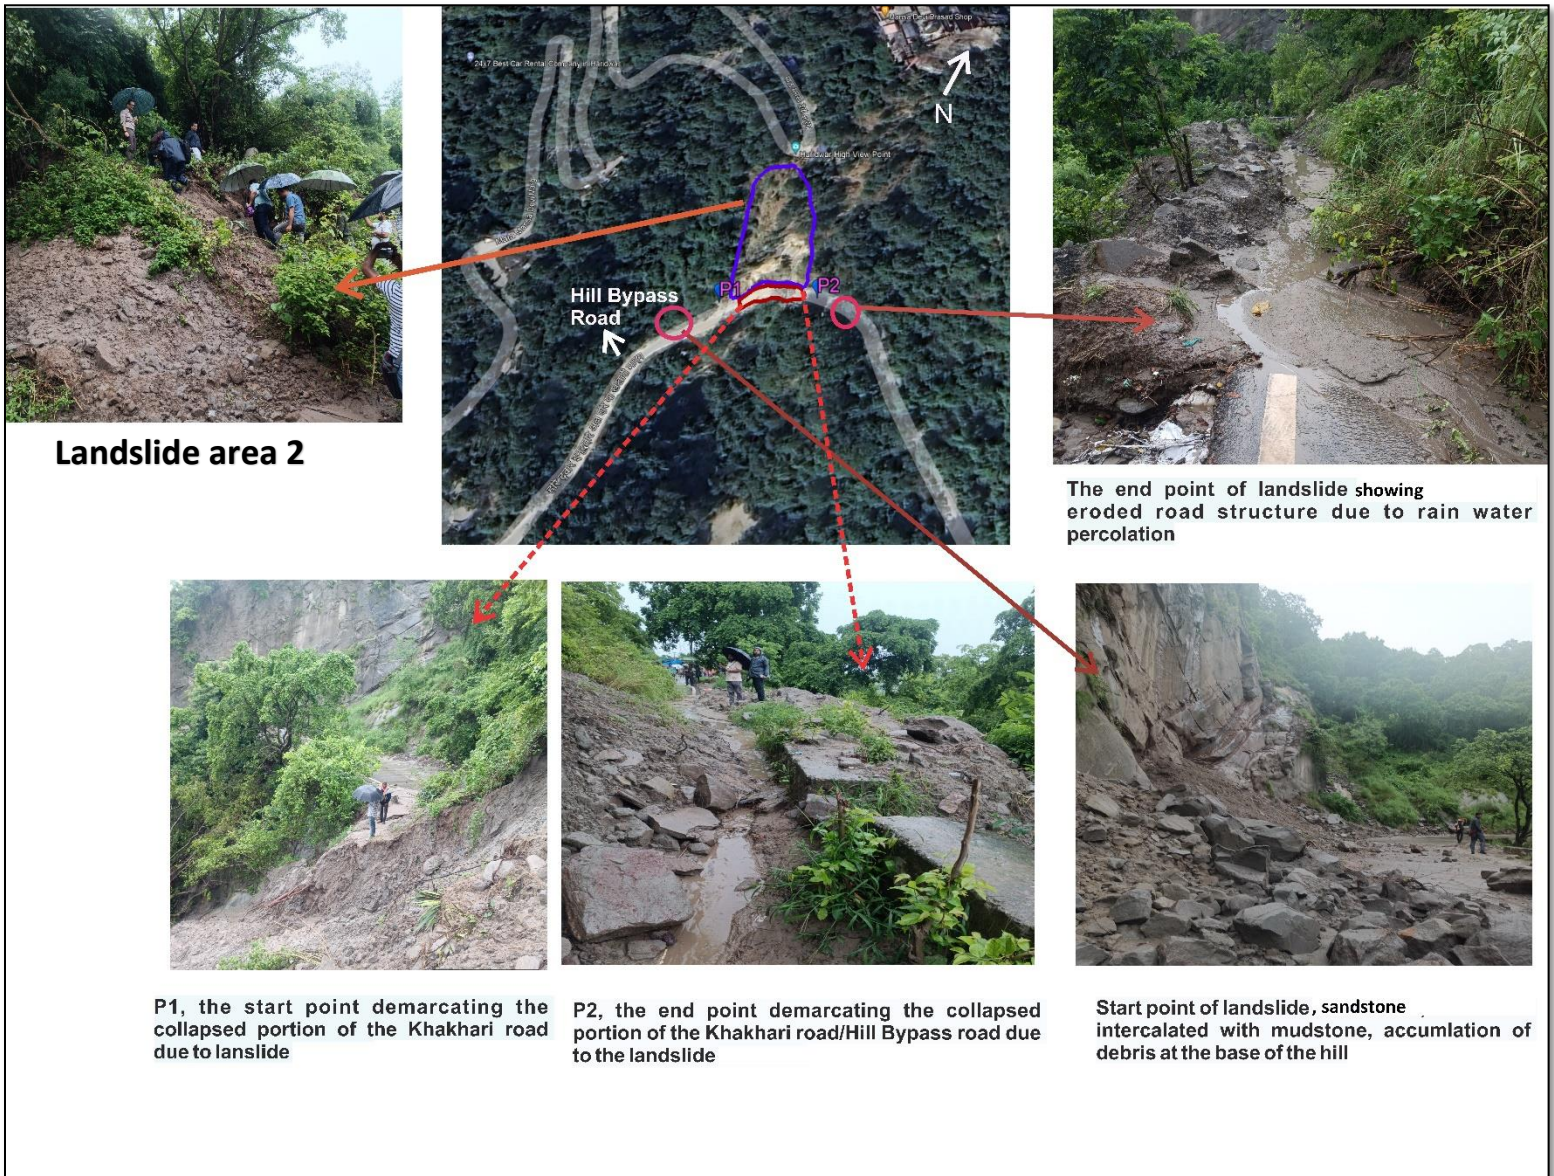
- ii. **Landslide area 2:** This location is situated between the coordinates points L1 (29.955853°N, 78.165664°E) and L2 (29.956259°N, 78.166019°E) along the Hill Bypass road, and is characterized by debris slide comprising mainly mud particles. The scarp of the landslide is ~ 120 m with a vertical height of around ~3 m, and a slope ~ 65- 70 °.

Due to its influence a considerable length (~80 m) P1 (29.956016°N, 78.165698°E) to P2 (29.956268°N, 78.166006°E) of the Hill bypass road (lying below this landslide area) collapsed. In accordance with the geology of this region, the mudstone formation under the trigger of rainfall has gushed down the hillock. This landslide hill lies adjacent to the hilltop where Mansa Devi Temple is located and the distance between the scarp and the step of the temple is ~ 3.0-4.0 m (Fig. 5).

Fig. 5: Google Earth image showing location of the second landslide, along the Hill Bypass Road, the points L1 and L2 mark the start and end point of the landslide stretch. It is observed that due to influence of this landslide a significant portion of Hill Bypass road has collapsed demarcated within P1 and P2 points. Each point marked in the Google image is explained in respect to field photographs.

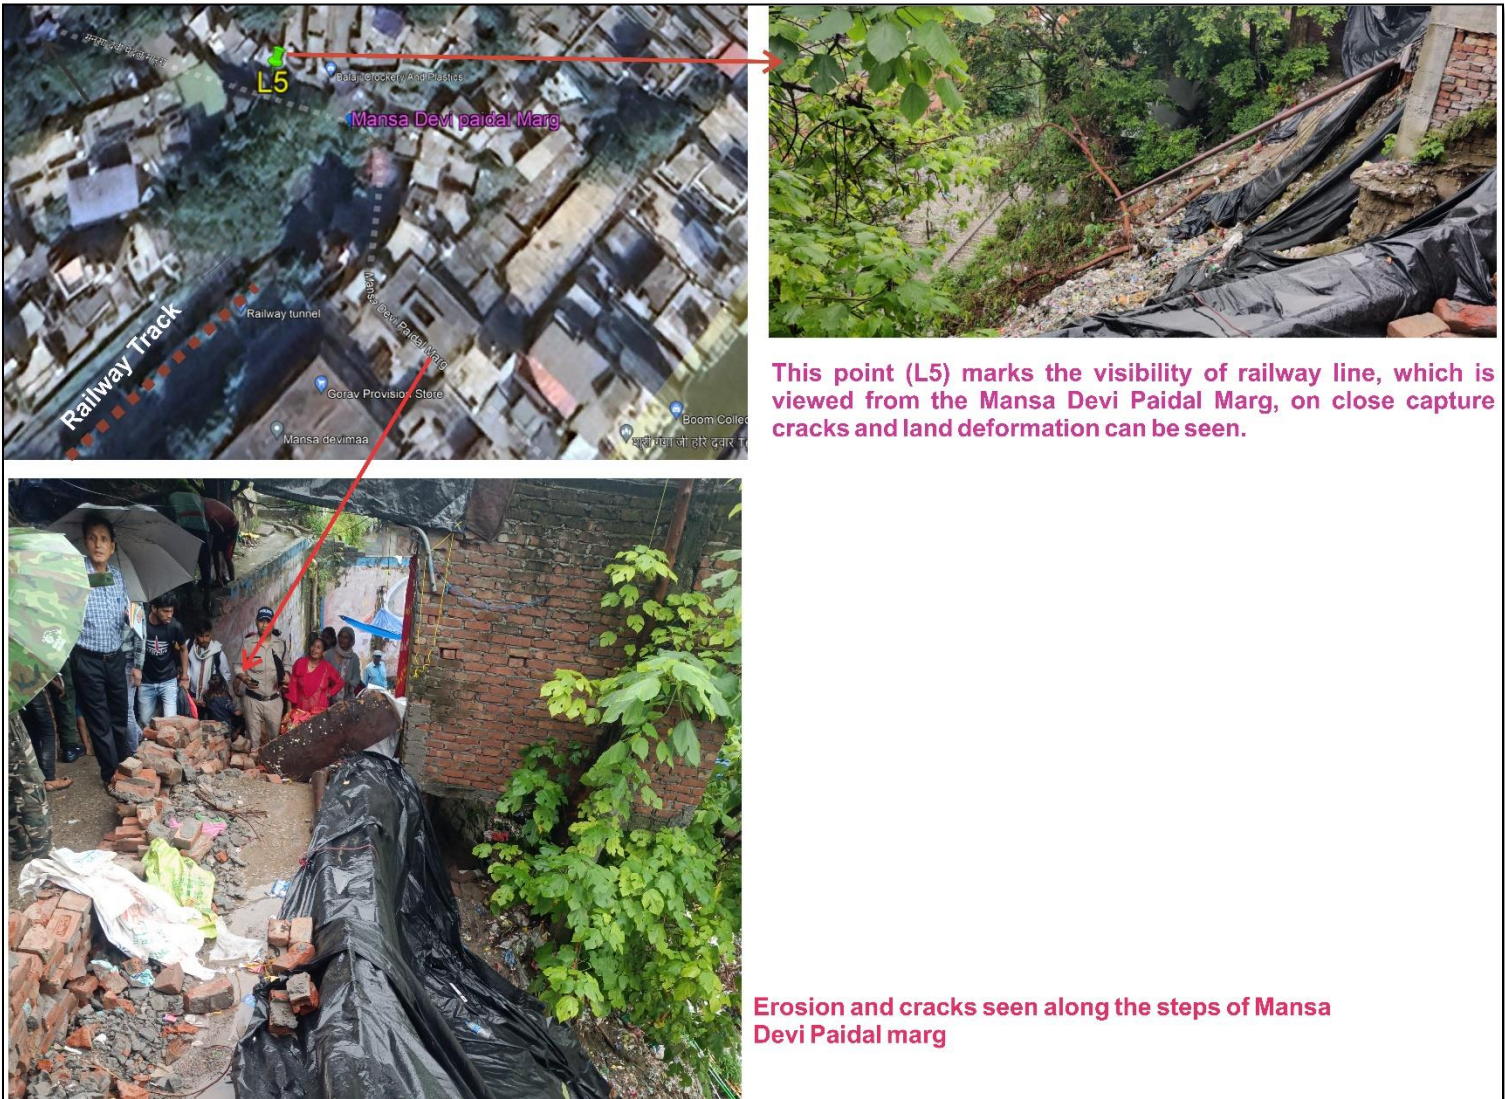
- i. **Mansa Devi paidal marg:** This location L5, is situated at coordinate points 29.955352°N, 78.167678° E adjacent to the Mansa Devi Paidal Marg road. At this location, we saw prevailing problems like erosion in the areas around railway tracks, visible cracks along the steps of the marg. Such a situation might be the result of entry of the debris fragments and improper drainage planning in the township (Fig. 6).

Fig 6: Google Earth image shows location L5 situated along the railway track, which is visible from the Mansa Devi Paidal Marg. It is observed that around L5, there is an accumulation of moist rock and mud fragments which is apparently adding an erosion effect to the surrounding. Likewise, the steps of Mansa Devi Paidal marg are also eroded and cracks appear in places. Each point marked in the Google image is explained with respect to the field photograph.

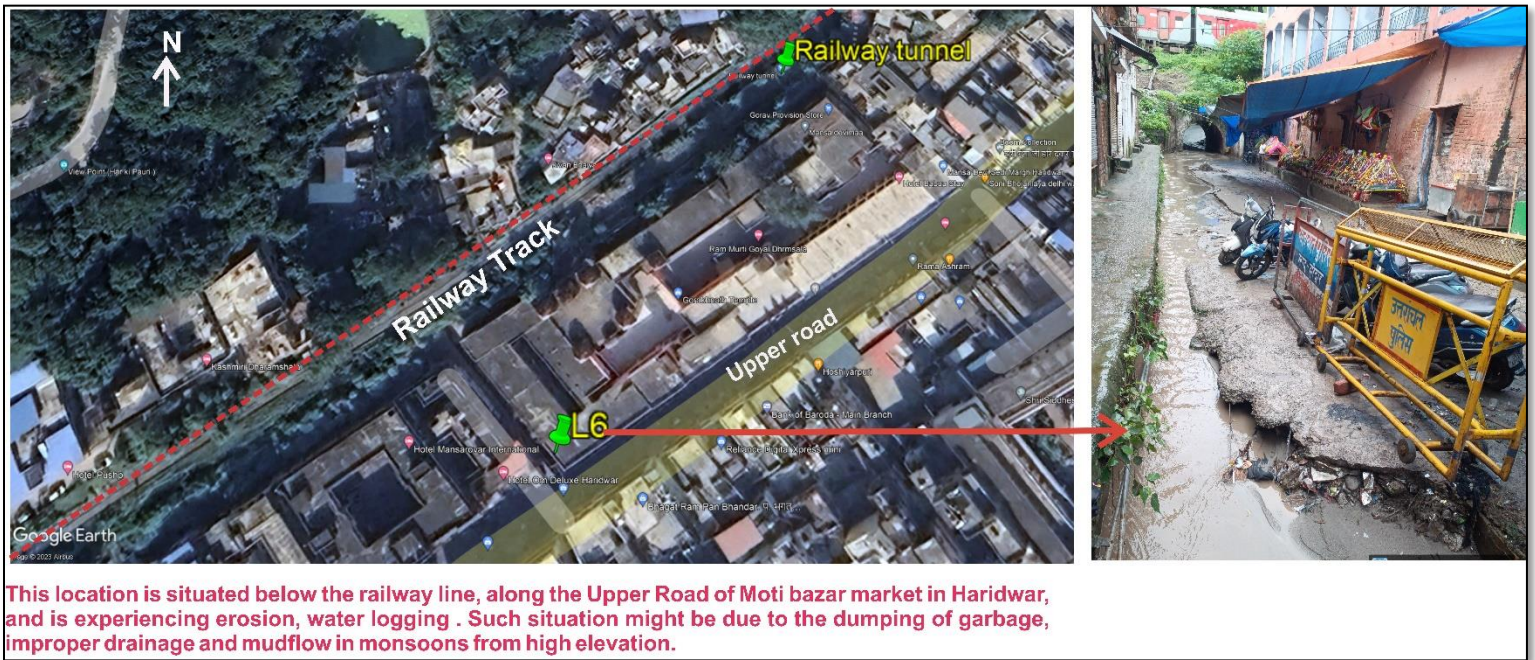
ii. **Haridwar market area:** This location L6 is located at the coordinate points 29.954055°N, 78.166972°E below the Haridwar railway track. At this location, problems like water logging and erosion can be seen, which has also sparsely flooded the market areas too. Such a situation might be the result of the dumping of garbage and improper drainage planning in the township (Fig.7).

Fig 7: Google Earth image shows the location L6, situated just below the Haridwar railway track. It is observed that the area around L6 experiences a water logging situation that has led to an erosive effect on the surroundings and adjacent to the market area. The location point on the Google Earth image is explained with respect to field photographs.
