विषय:—जनपद उत्तरकाशी, तहसील भटवाडी के अन्तर्गत ग्राम मस्ताडी में भूमि के अन्दर से हो रहे पानी के रिसाव के सम्बन्ध में जियोफिजिकल/जियोटैक्निकल सर्वेक्षण करवाये जाने के सम्बन्ध में।

Survey Report on Mastari Village, Uttarkashi District

Uttarakhand Landslide Mitigation and Management Center (ULMMC)

August 2023

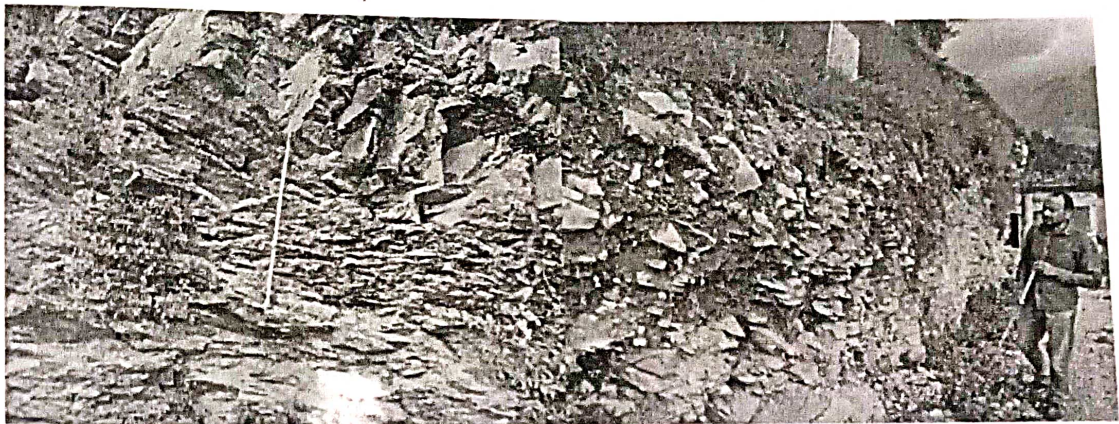
- 3-: In the eastern part of the village, quartzite rock formations are visible, while in the central part of the village, large boulders were observed, suggesting the possibility of an old landslide.

Figure 1- Weathered rock formation on the north-eastern side

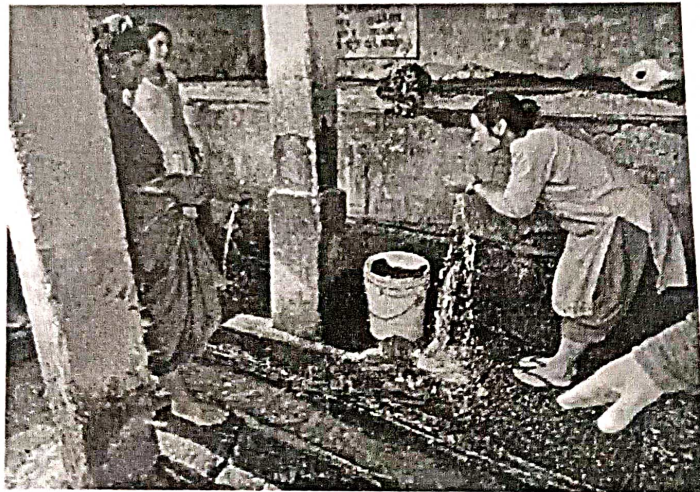
- 4-: In the central part of the village, near the Nagrajara temple, there is a natural water spring with two outlets, ranging in diameter from 15 mm & 50 mm. During the rainy season, the discharge of water increases, but during the dry season, only as much water flows as from a 15 mm diameter hole, as informed by the villagers.

Figure -2 Natural spring at the center of the village

3-: The water used for irrigation and exiting from the houses, as well as the water from springs, should be safely disposed to downstream through well-constructed channels.

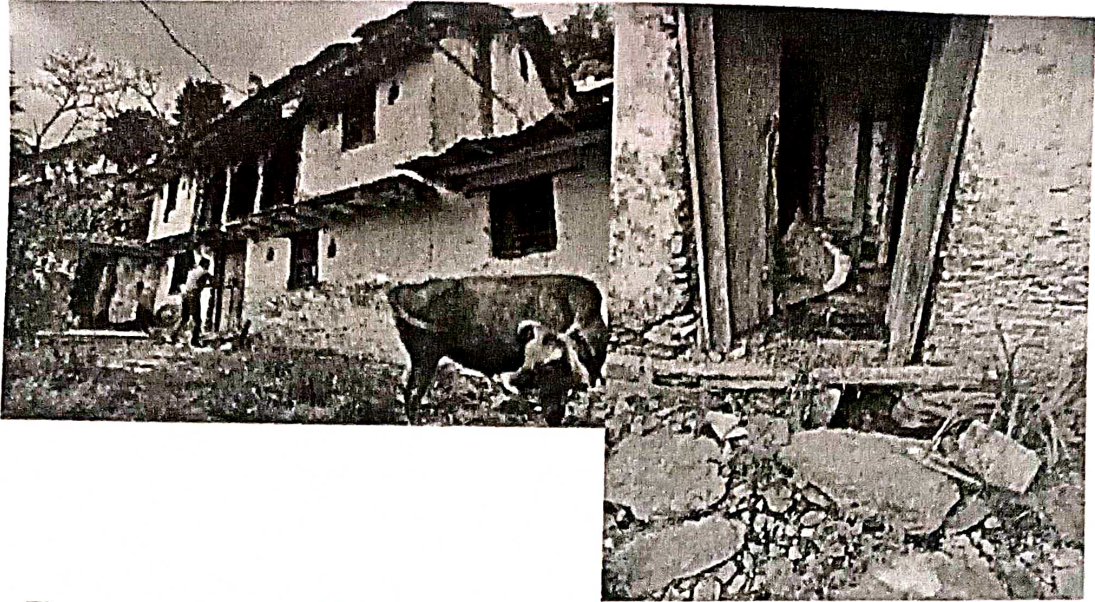
- 5-: In the village, two houses were found where there is a natural spring water flows beneath the floors. It has also been noted that the water flow occurs only during periods of heavy rainfall, as both of these houses are situated on the lower side of the natural spring. These houses are more than 40 years old.

Figure -3 A house with water seeping out from beneath its floor.

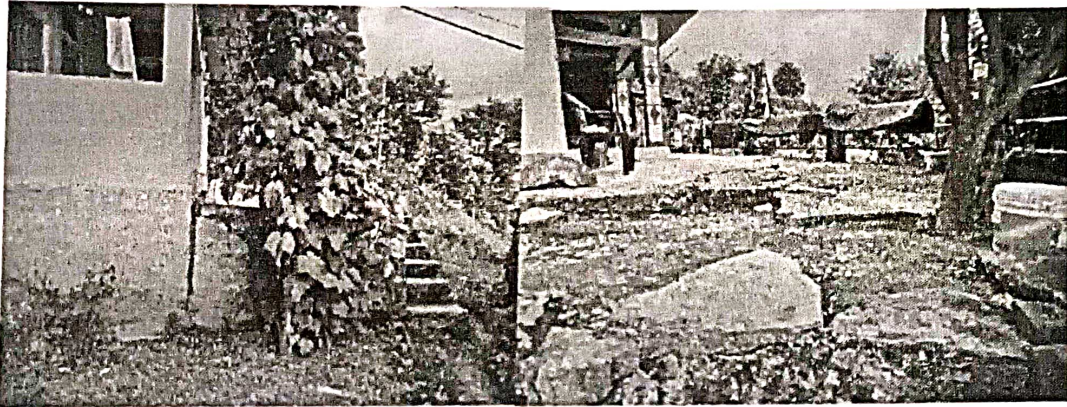
7-: Cracks have been observed in 3 to 4 houses in the village, particularly affecting areas where new construction has been joined onto existing structures. Most of these houses are located towards the eastern side of the village.

Figure -4 Minor Crack on the outer courtyard

2-: If possible, the cracks can be measured between the rainy and dry seasons by some simple technique may be installing some crack meters. This will indicate whether actually the development of cracks is associated with rains and sub-surface water flow.

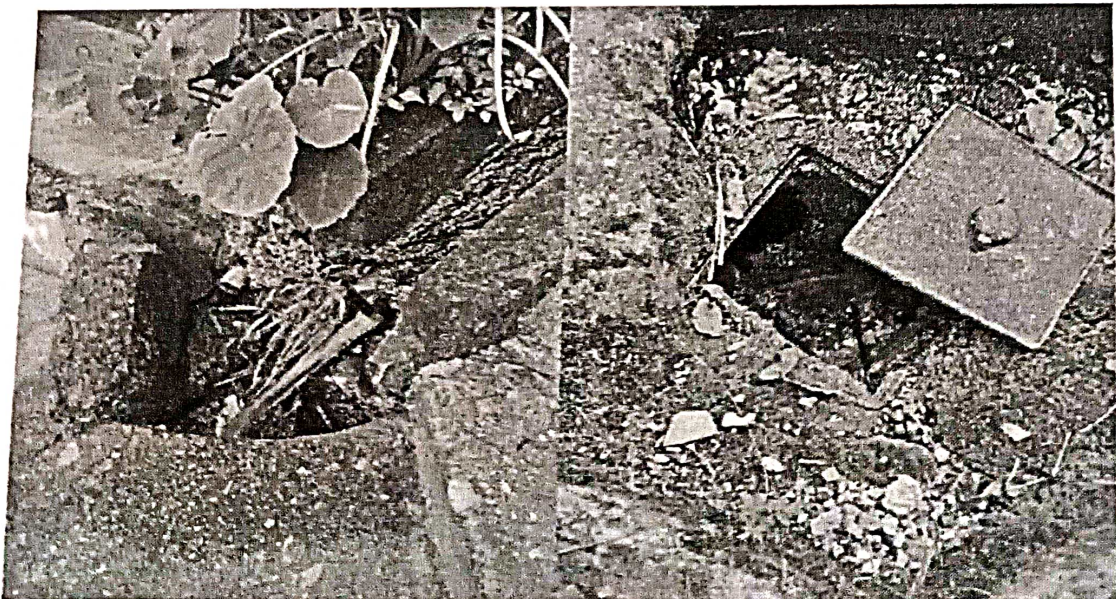
8-: During the dry season, for the extraction of water from the natural spring, a 300x300mm chamber along with a 100mm PVC pipe has been constructed in the interior part of the village. Additionally, provisions have been made to cover the pipe during the rainy season to prevent overflow, with the use of cement concrete channels.

Figure-5 Spring water flowing through a PVC Pipe with Chamber.

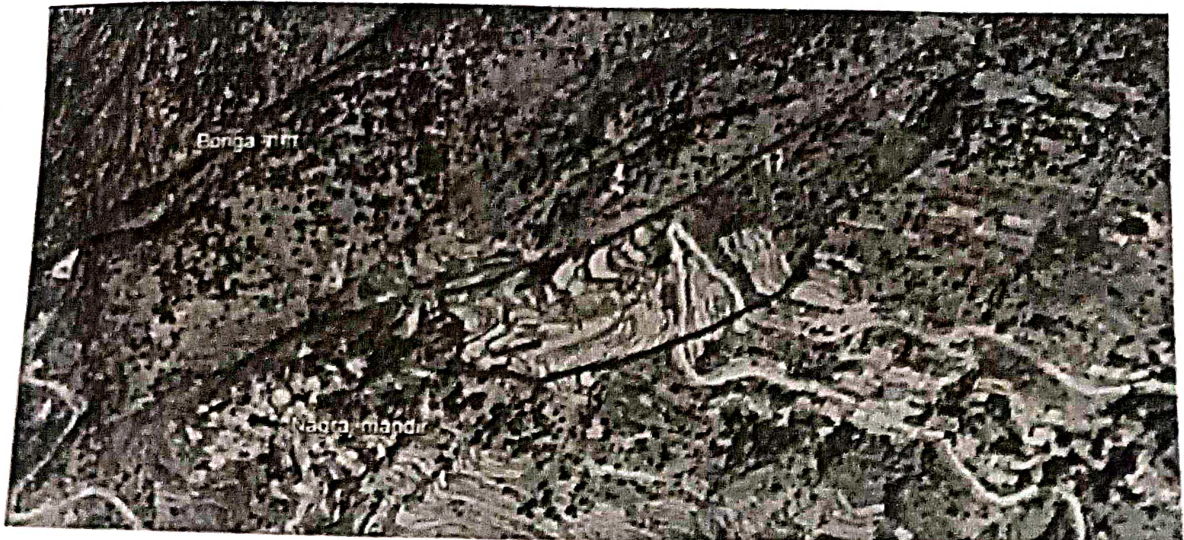
Figure -6 overview of Village
