A Report on Naina Devi Landslide

May 2023

**Uttarakhand Landslide Mitigation and Management Center
(ULMMC), Dehradun.**

Report on Field visit of Naina Peak Landslide, Nainital

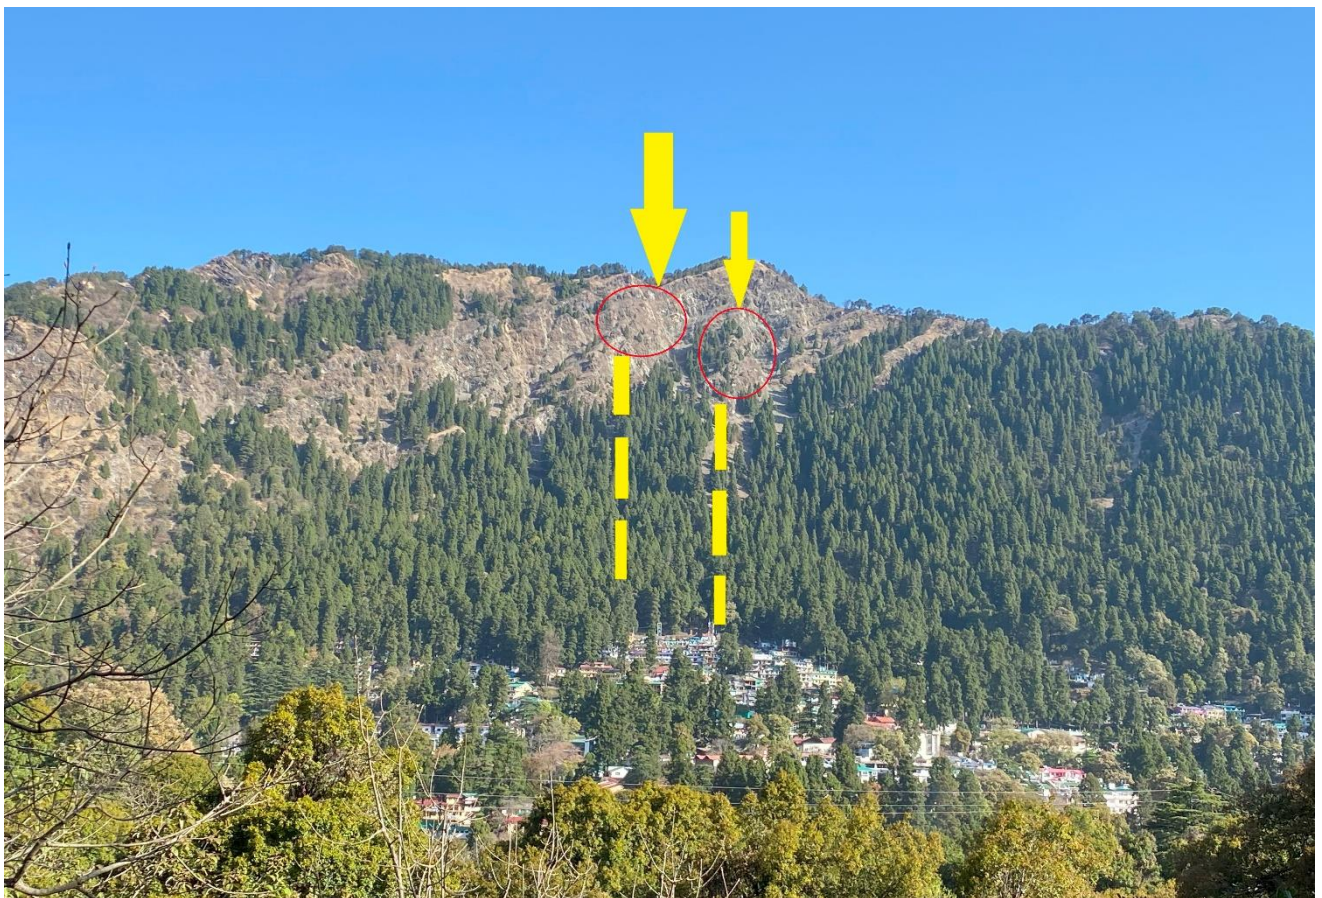
Figure 2: Panoramic view of Naina Peak landslide and the settlement just below the rock fall zone

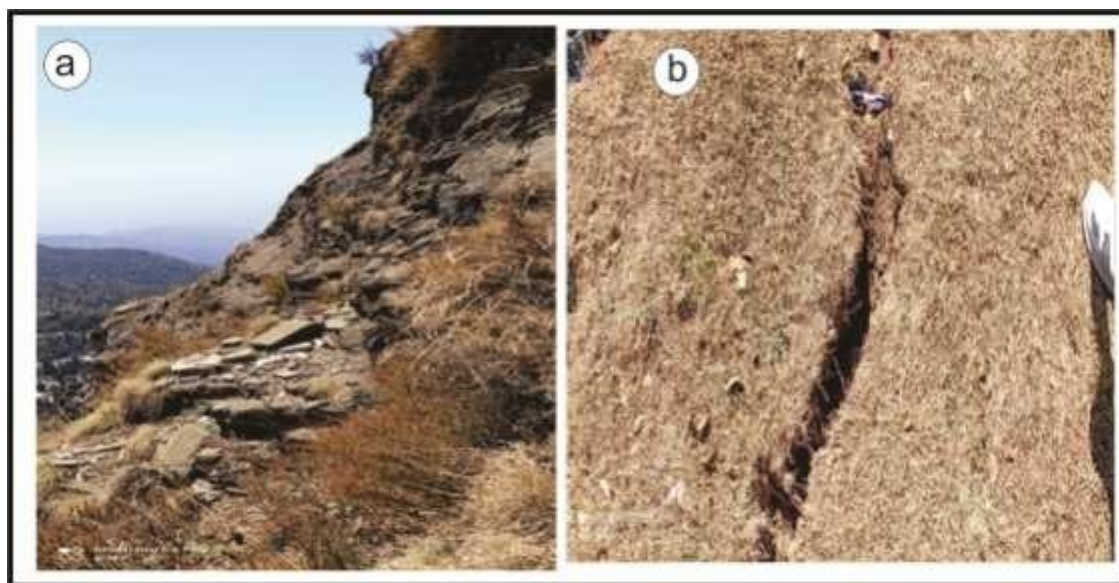
Geomorphologically, the slope in the upper and the middle part of the hill is near vertical and $\sim 70^\circ$ respectively whereas at the base it is $\sim 30^\circ$. The middle part of the slope is covered with thick forest whereas at the base settlements are situated. The Naina Peak landslide is situated near the crest of the slope. To the west of this landslide, numerous tension cracks having $< 2\text{m}$ long and $> 50\text{ cm}$ wide were observed at several locations (Fig 4b).

Figure 4: (a) highly shattered and jointed condition of rock mass exposed at crest of Naini Hill (b) tension cracks on the crown of Naini peak

- Seepage of rain water into the slope must be avoided in order to arrest any further movement in the crown portion of the slope.
- Scrapping of the loose filled overburden material from the slope causing instability.

- Open cracks must be filled with the impermeable material at the site with help of local materials present in nearby areas and compact the material to achieve required dry density.

- Further few critical spots were identified during the field where several open tension cracks (~50 cm in length) are present. These should be covered with light weight material as to prevent the seepage of rain water and must be divert the flow of water to other side of the hill slope.

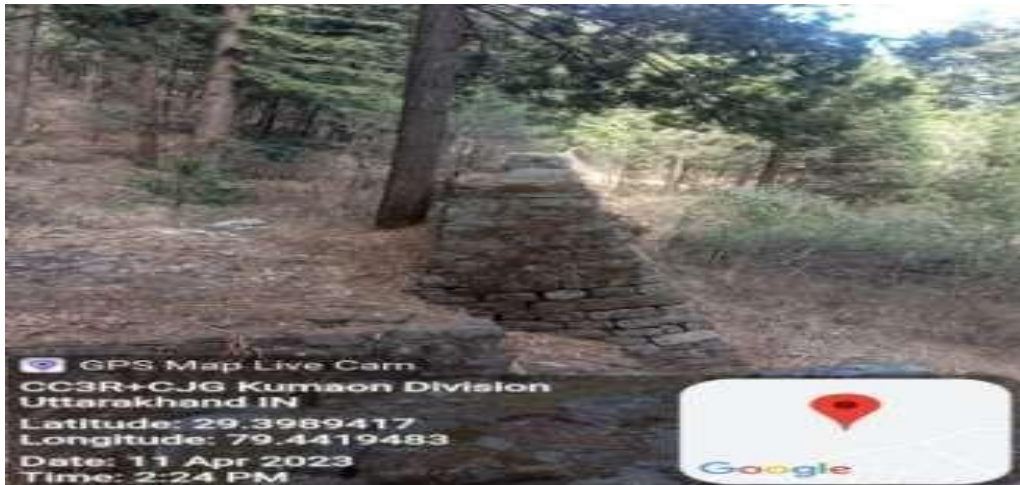
The area between the toe of the slide till kilbury road is covered with the moderately dense forest. The slided material/slope wash material stopped to enter into settlement area through the retaining structure (Figure 6) constructed in the middle of the slope at various elevations that has successively reduced the velocity of the falling rock debris. The average dimension of rock pieces is 50-100 cm (Figure ...).

Figure 6: Retaining Wall structure above the Kilbury Road

- Since the rock fall activity is continuously occurring for a long time and debris/rock chunks are collected at the previously build retaining walls at different levels, it is suggested that these should be removed in order to create space for further debris collection.

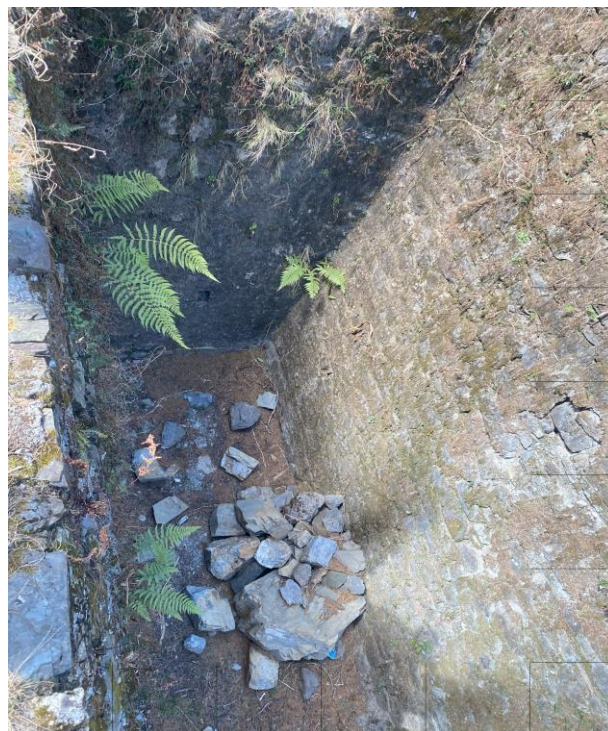
Figure ... The slided rock pieces obstructed by the retaining wall

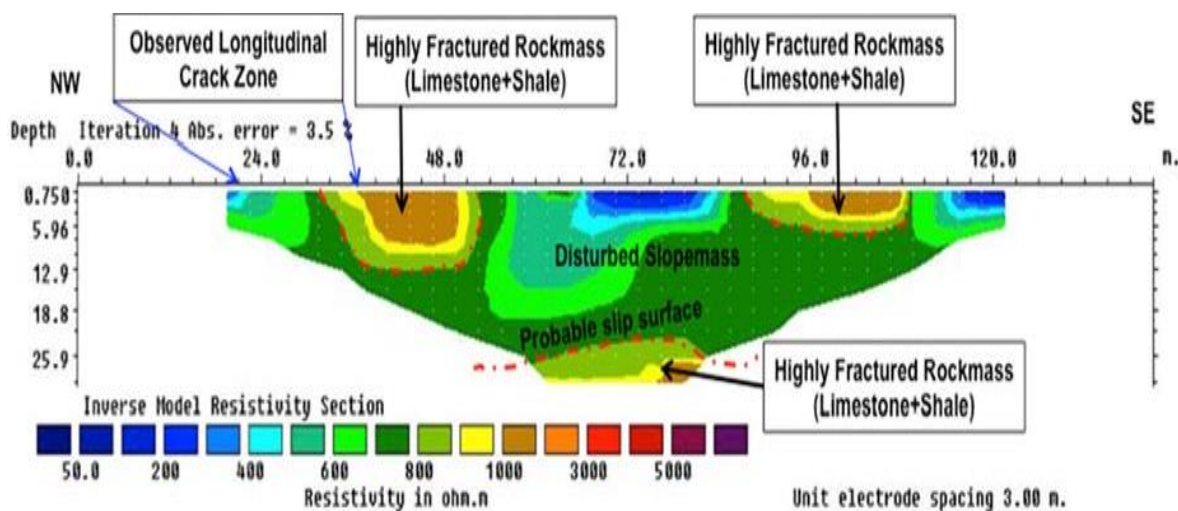
The inverse image of the ERT profile line is given in Figure 5. The ERT image is interpreted in terms of depth and type of sub-surface material layers and probable slip surface. Two different material layers could be interpreted at this site (i) the disturbed slope mass material (debris) layer with lower resistivity (<800 Ωm) values and (ii) the highly fractured incompetent rockmass layer (i.e., shale alternating with limestone) with middle range of resistivity values (800-1100 Ωm). It has been interpreted that the top layer is mostly dominated by disturbed slope mass debris material comprising of silt, clay and rock chips with stray patches of highly fractured incompetent rockmass at two places as observed at the site. Beyond 20-22 m depth, highly fractured incompetent rockmass layer with similar range of resistivity values as observed on the surface (i.e., 800-1100 Ωm) was found. Therefore, it can be inferred that the probable slip surface of this portion of the Naina peak landslide zone may exist at the interface between disturbed slope mass debris material and highly fractured incompetent rockmass layers at a depth of about 20-22 m.

Figure 5: Inverse image of ERT profile at Naina Peak landslide

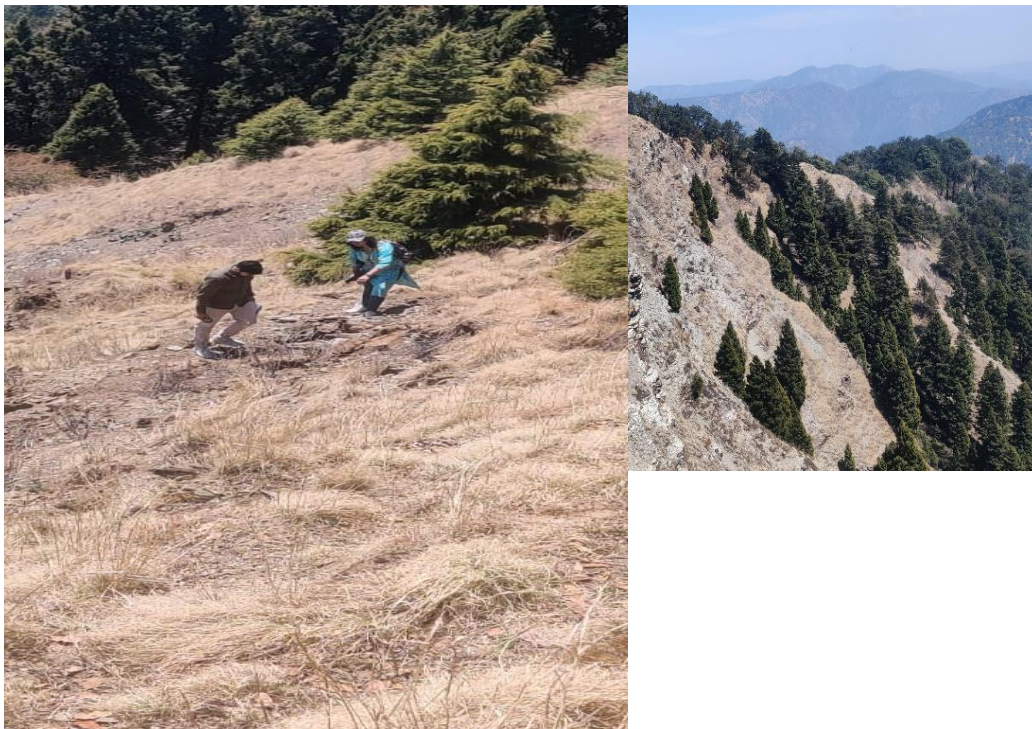
- The entire slope is composed of shale which is a soft rock and very prone to weathering. The rocks are highly fractured and jointed and forming rock pieces which are falling and rolling down the steep slope (Figure....).

Figure 7: Shale rocks falling from landslide zone.

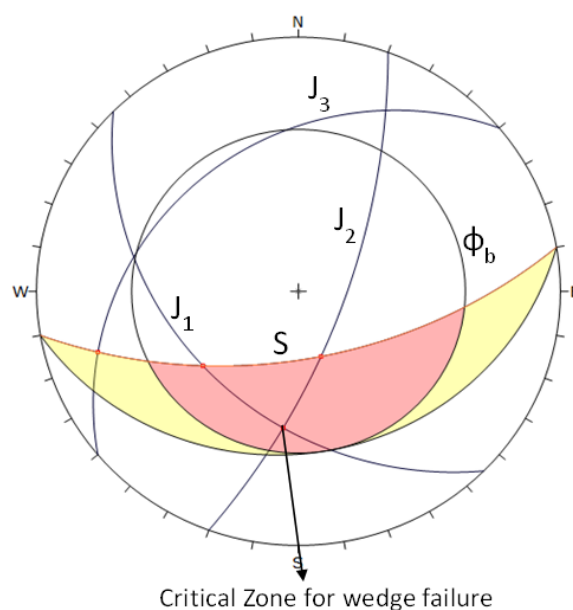
Kinematic analysis indicates the wedge failure formed by the intersection of joint J_1 and J_2 . Here, the plunge angle is less than the slope angle but greater than the basic friction angle that is the condition of wedge failure.
