Report
on
Field Expedition program on glacial lake outburst floods (GLOF),
Sikkim

Dr Ruchika Tandon
(Senior Geologist)

Uttarakhand Landslide Mitigation and Management Center

September 2023

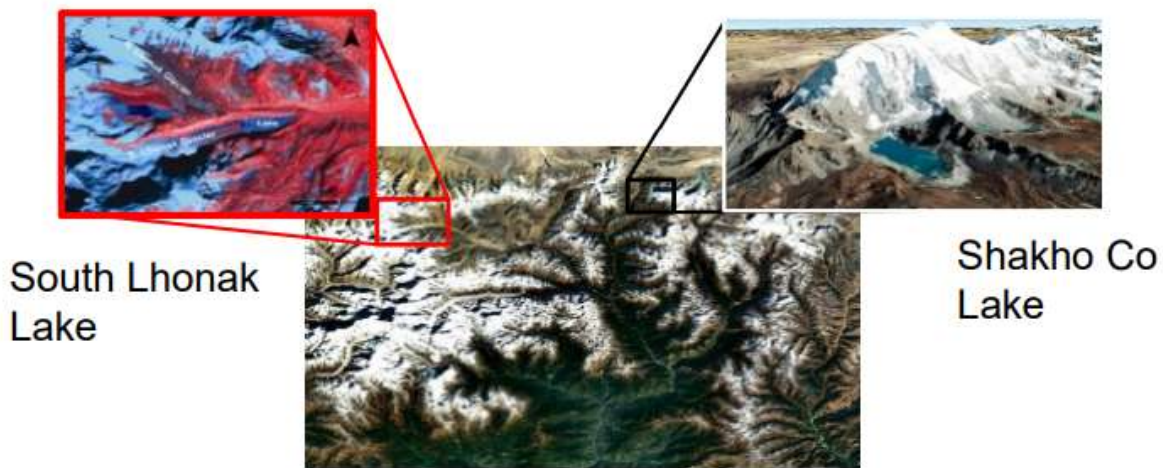
Figure 1 depicting the satellite view of Shako cho and South Lhonak lake

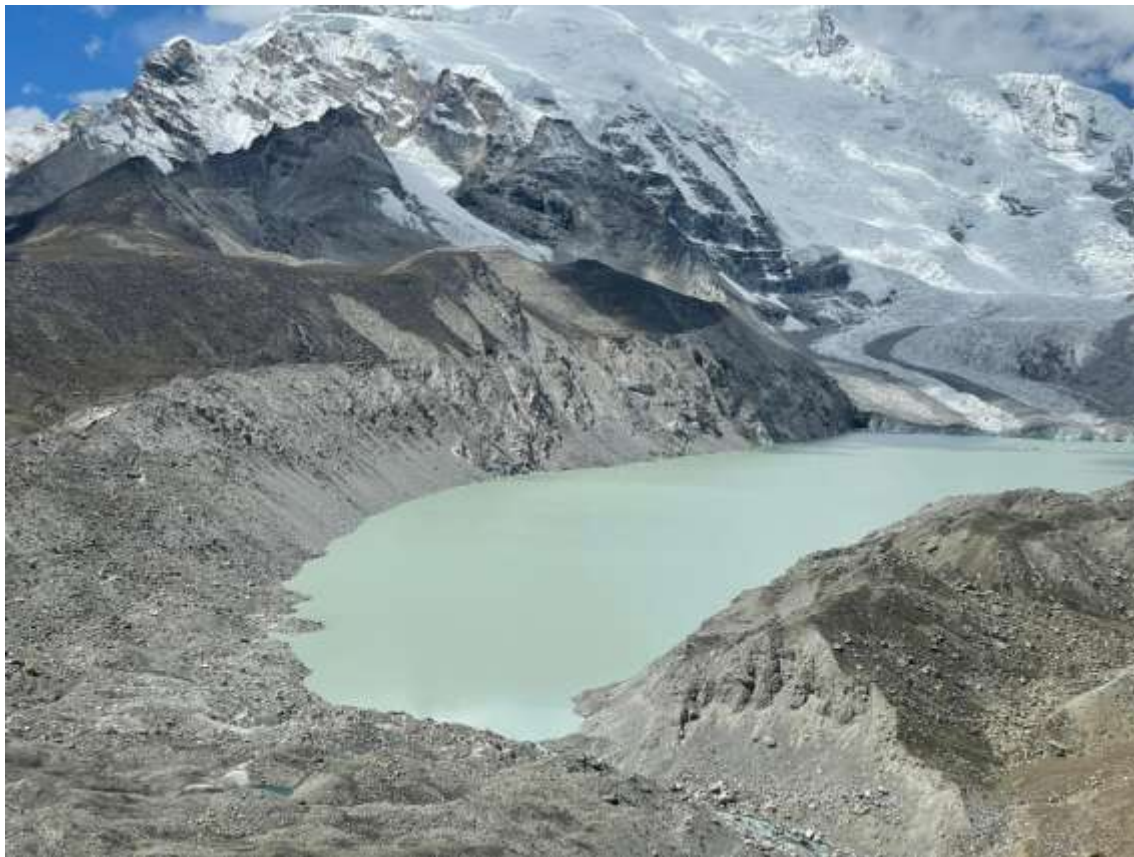
The **South Lhonak lake** is morain dammed lake (27°54'20"N and 88°10'20"E) and located at an elevation of 5,200 m (17,100 ft) above sea level in the Teesta Basin, Sikkim, Himalaya (Fig. 2). It formed due to the melting of the Lhonak glacier. The lake is rapidly growing in size in an

abnormally rapid manner due to the melting of the lake's associated South Lhonak glacier and additional melt water from the adjacent North Lhonak and main Lhonak glaciers. The frontal moraine damming the lake has a width of approximately 500 m and it gets narrow towards the north, where a surface outflow from the lake is located. The surficial outflow channel cuts the moraine dam in the north-northeast direction while the main valley is oriented towards the east . The crest height of the frontal part of the damming moraine (south from the outflow channel) is 7 m above lake.

Figure 3 Schematic view of South Lhonak Lake

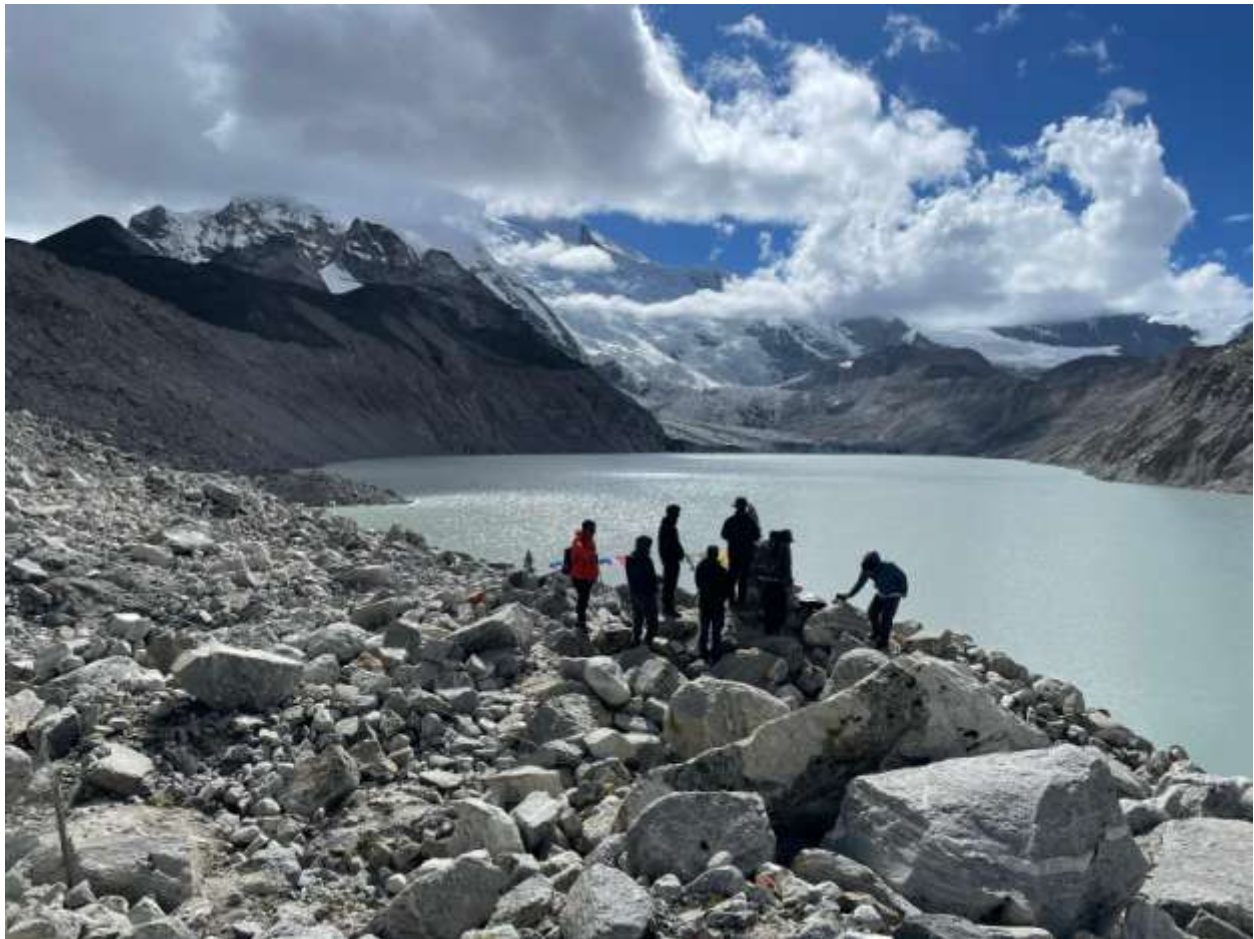
The **Shako Cho glacial lake** ($27^{\circ}58'29''\text{N}$; $88^{\circ}36' 58''\text{E}$) is located at 5000 m a.s.l. in the northern part of Thangu valley. The lake is located approximately 10 km upstream of the nearest settlement of Thangu village (3900 m a.s.l.). The Shako Cho Lake is a large proglacial in Sikkim and is highly critical due to various key indicators including low width-to-height ratio of the end moraine, steep damming moraine composed of loose granular material, the presence of a 1000-m high mountain slope rising above the lake, and the location of nearest Thangu village . Previous

studies reported that, as the freeboard of the damming moraine is 10 m, mass impacts into the lake from the mountain face above the lake can lead to dam overtopping waves (Worni et al., 2013). The dam is susceptible to erosion due to the sharp dam and weak dam structure (Worni et al., 2013). The flow channel originating at the lake is geometry characterized by steep side slopes and a lack of vegetation in the upper part till the nearest settlement at Thangu.

Figure 4 Schematic view of Shako Cho Lake

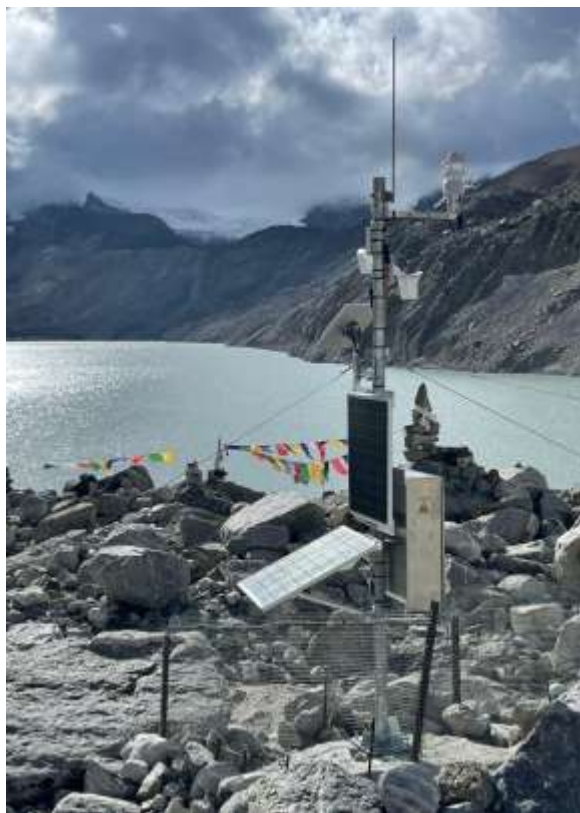
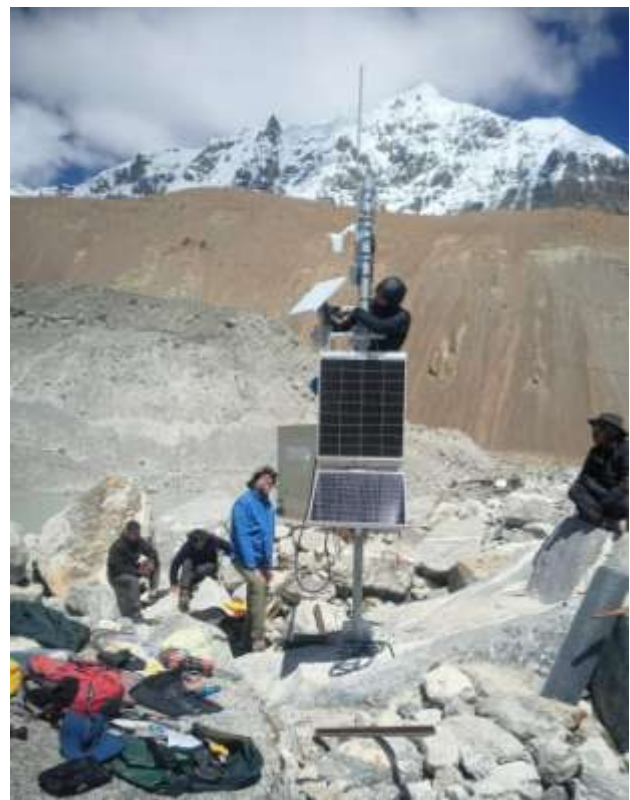
The installed monitoring instruments consist of two webcams (wide angle view and normal view), two solar panels and automatic weather station(AWS). The high definition images provided with web cameras, allow for automatic deformation analysis of the monitored area and allow to identify even small details within the monitored area. An AWS typically consist of a

enclosure containing the data logger, rechargeable battery, minicomputer/screen and the meteorological sensors with an attached solar panel. The two solar panels used are angled in such a way that during intense snowfall if one panel is covered with snow the vertical solar panel will work on reflected sunrays. As an advantage, if the area does not get sun light for various days then the system may not charge but automatically started working when the panel receive sunrays. The meteorology sensors gives data on temperature, humidity, precipitation, wind Speed, Wind direction and radiation. All these data will be recorded and communicate through satellite in Geoprevent portal which will further examine and helpful to develop Early warning system. The online data portal connects, visualizes, and provides the relevant information up-to-date. Also the advantage in the swiss make monitoring device is its support of 2 way communication . if any error occur then it may possible to detect the problem remotely.

Figure 5 depicting the installation of monitoring instruments at Shako Cho and South Lhonak lake sites by Swiss Experts

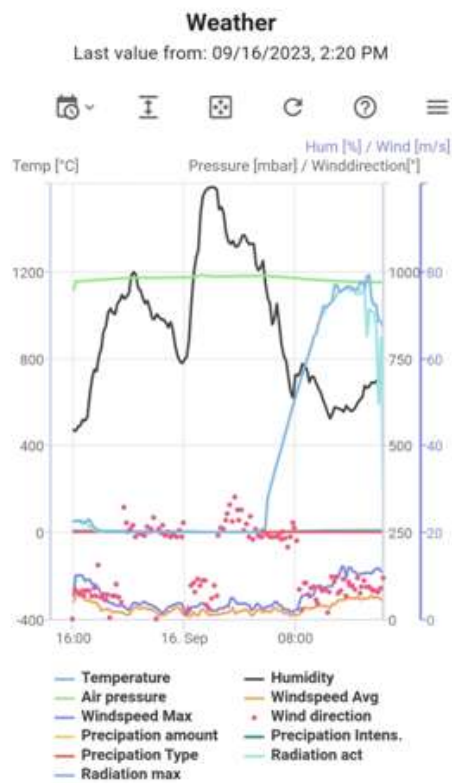
Figure 7 depicting the graph of various meteorological data obtained on 16th Sept 2023 after installation of monitoring device at the Geoprevent Portal.
