Field visit Report on Landslide Site
(Village-Jakhan, Panchayat-Madrasoo, Tehsil Vikasnagar)
Dated: 17 August 2023

To study the possible causes/reasons of the current landslide/slope failure at Linghaf Road which impacted the Village-Jakhan. In compliance of orders received from Director General, ULMCC, a team of following officials visited the site on August 17, 2023 -

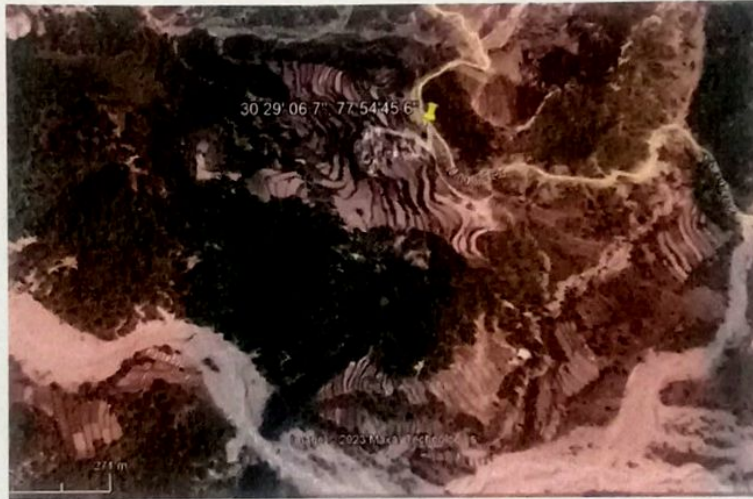
A transmission line (Vyasi Hydro Power) is also passing through the vicinity. There is no new road cutting or road, no deforestation, no industrial establishment and no perineal waterbody but a seasonal waterway crossing the farms of the village & flowing towards valley side. Further, entire arable land within the vicinity is rainfed and even there is no source of micro irrigation. Following satellite image of the vicinity may depict the pre-devastation state of landscape-

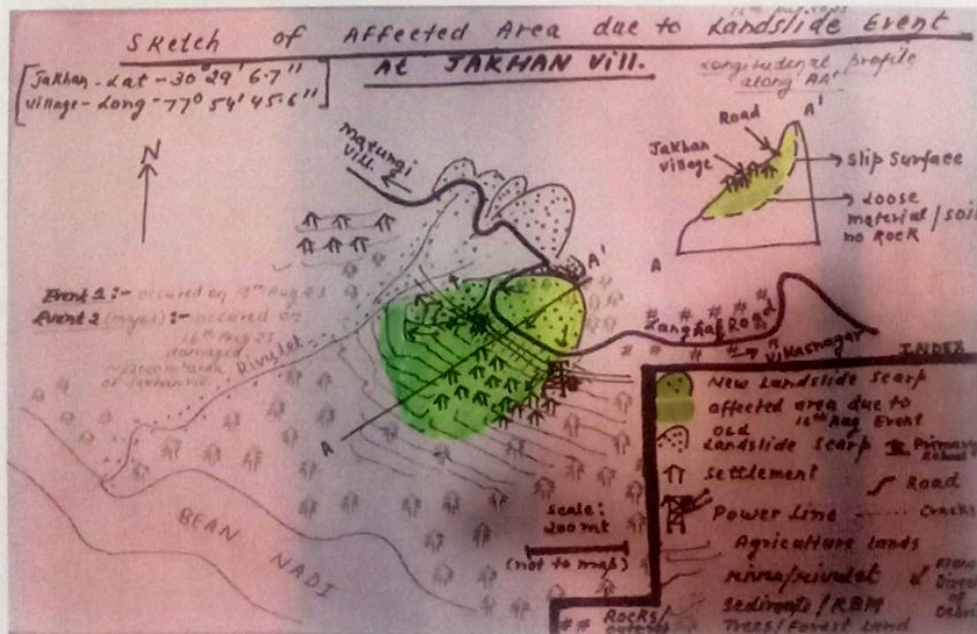
Geologically, it falls under Lesser Himalayan sequence comprises of meta sedimentary rocks mainly shale and slate exposed near to affected area whereas at the affected site, there is no outcrop observed. However, the slope forming material having chunks of shale and slate embedded in silty sandy matrix suggested its weak nature/ presence of fault. Towards the left side of the affected area along Linghaf road, well bedded shale is exposed which is of grey in colour and thinly bedded. Geomorphologically, the area has average moderate slope. Above the linghaf road, the slope is steep and has gradient of 65° whereas below the road it is 40° . The slope is cut into gentle steeped like terraces for agricultural practices. The sketch of the affected area (marked as green in colour) as under-
