**Preliminary Site Investigation of Landslides and Associated
Distress along the Hill Bypass Road around Mansa Devi,
Haridwar**

**Uttarakhand Landslide Mitigation and Management Centre
Government of Uttarakhand
August 2023**

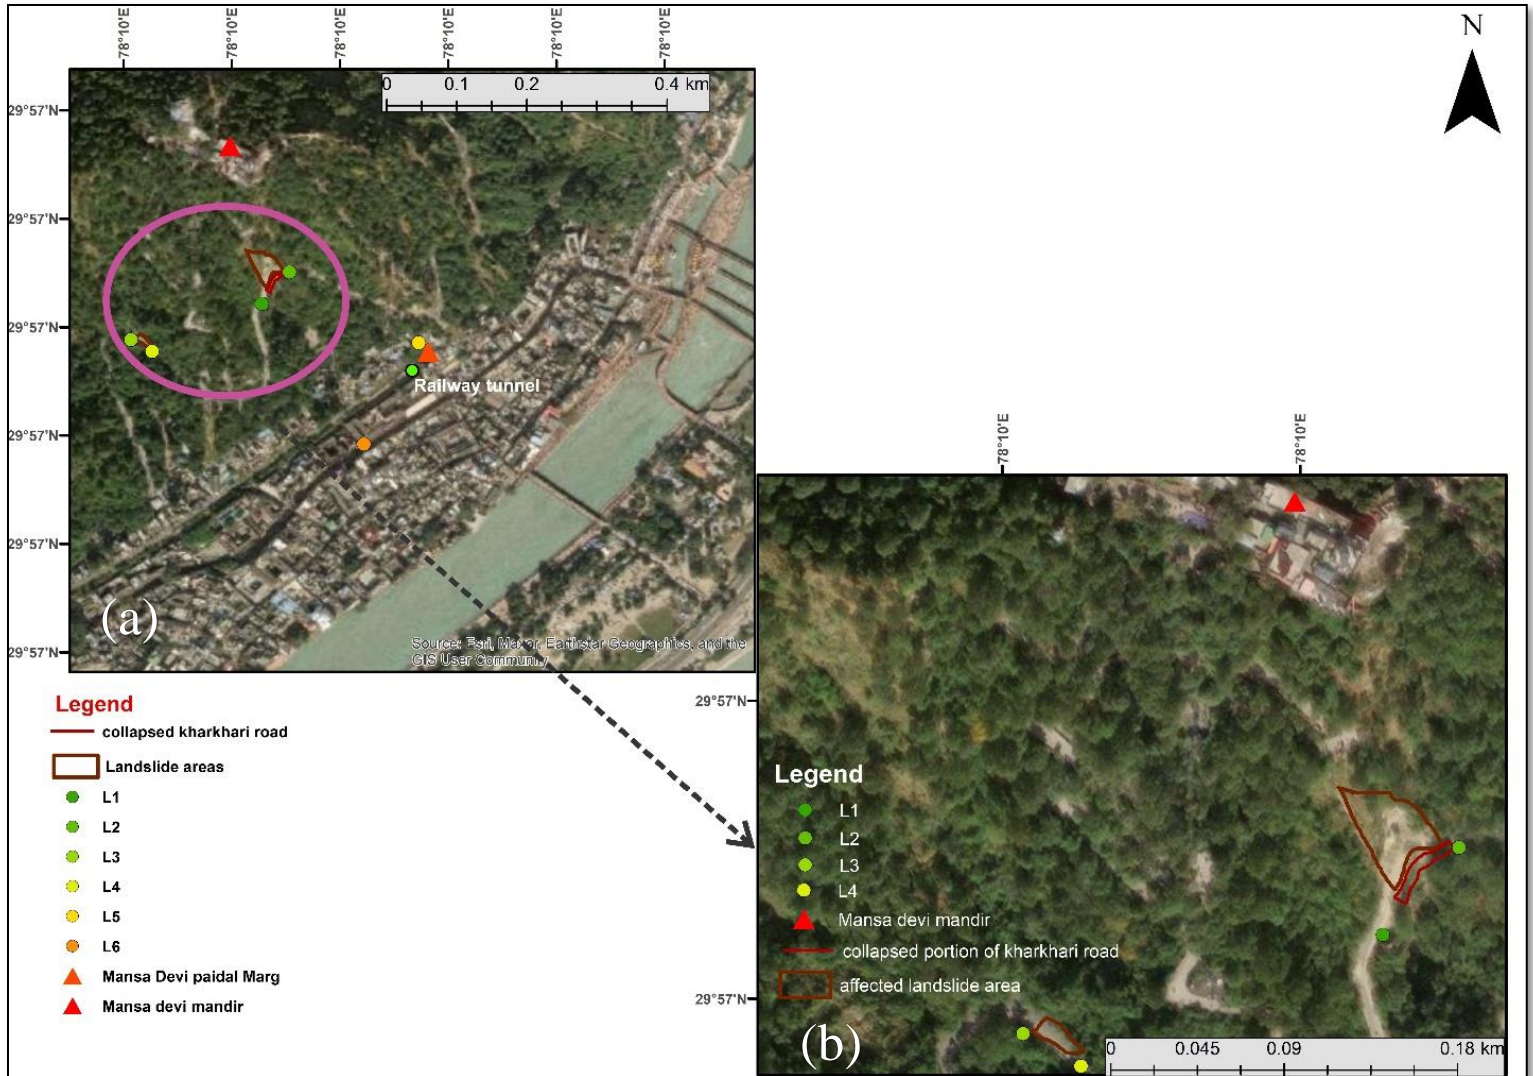
The major portion of the road is in a dilapidated state and has become vulnerable to upslope and downslope failures which may be potentially hazardous for the population at the hill below. Considering this risk of slope failures, it is wise to maintain the road effectively so that it acts as a less potential danger to the settlements below (Fig. 2) (Tandon et al. 2020).

Fig. 2: (a) Location map showing the points where preliminary survey is carried out (b) The pink circle marked in (a) is extended further which highlights two major landslide areas along the Hill Bypass road
