A Report on Naina Devi Landslide

May 2023

**Uttarakhand Landslide Mitigation and Management Center
(ULMMC), Dehradun.**

Report on Field visit of Naina Peak Landslide, Nainital

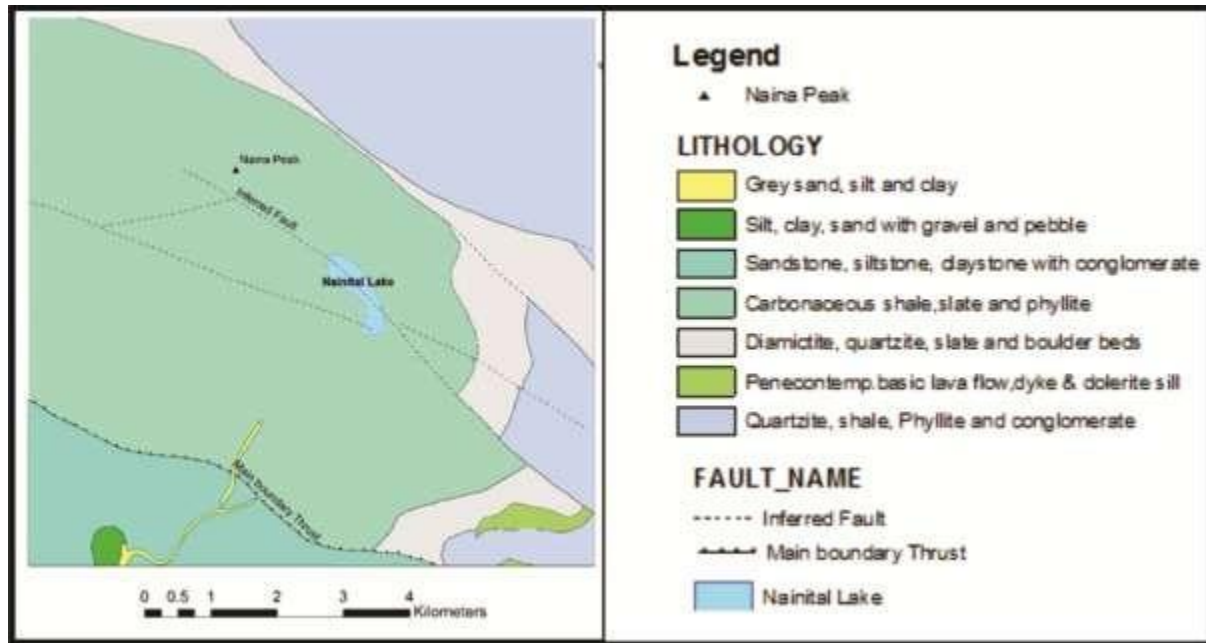
Figure 3: Geological Map of the area

Naina Peak area dominantly exposes the rocks of the Lower Krol Formation along with the patches of the Middle Krol Formation and the Upper Krol Formation. The geological map of the area is shown in Figure 3. Geologically, the rock type exposed in and around Naini Hills are thinly bedded Shale with intercalations of Limestone. The rocks are highly weathered, shattered and jointed near the top of the hill (Fig 4) whereas rocks exposed in the middle and lower part of the slope is relatively competent. The rocks dip 25° towards N300° (bedding joint). Apart from bedding joint, there are four to five joints sets present in the area.
